EXPERIENCE IN APPLYING PERMEABLE INTERLOCKING CONCRETE PAVING IN AUSTRALIA

SUMMARY

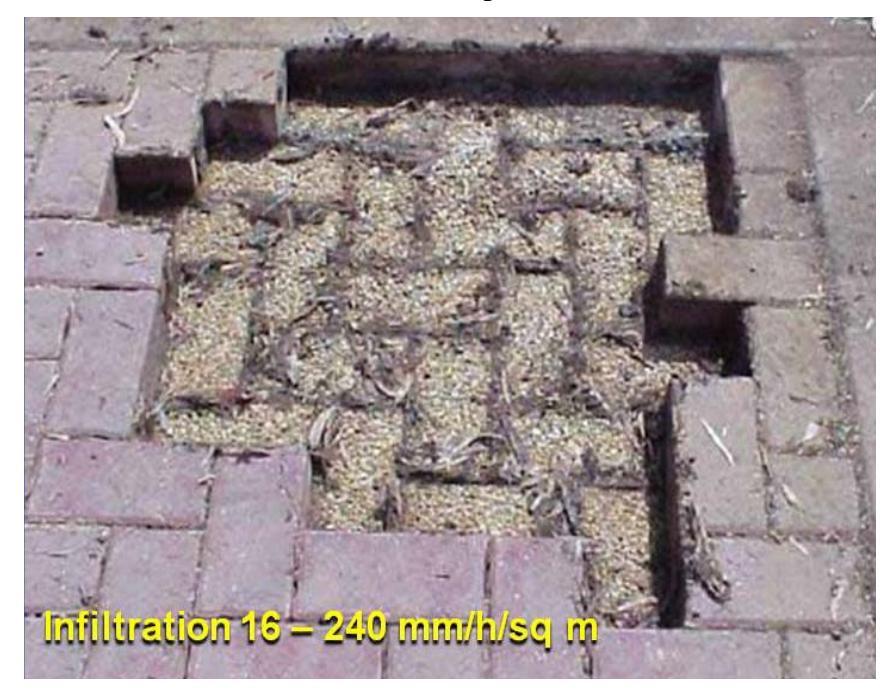
Figure 2. Excavation at Kirkcaldy Avenue showing penetration of sediment down open joints

The lowest infiltration rate, at Kirkcaldy Avenue, Grange (SA), represents an exception to this trend. This pavement has a low surface slope and previous measurements (Pezzaniti et al., 2009) show the development of a 'clogging front' extending from the upstream region of the pavement. As noted earlier, this pavement was installed without jointing material between the pavers and was therefore more vulnerable to sediment completely clogging those joints upstream of the clogging front. The infiltration rate for Victoria Road, Largs North (SA), shown in Table 2 is recorded as too high to be measured using an infiltrometer. This reflects the fact that the pavement was laid with open unfilled joints which allowed considerable lateral movement of water away from the infiltrometer as well as infiltration down into the pavement substructure. Whilst this site showed the highest infiltration rate of those observed and is in agreement with previous studies (Urban Water Resources Centre, 2002 and Pezzaniti et al., 2009) the results must be treated with caution because the

use of unfilled joints. Open joints also permit sediments to travel down to the bedding layer rather than being trapped in the jointing aggregate. This is shown in Figure 2 (after Pezzaniti and Beecham, 2008) for the Kirkcaldy Avenue site. Here sediment can be seen to have reached a geotextile laid on top of the base. Such sediment can only be removed by completely lifting and relaying the paving rather than by sweeping the surface. Moreover, as noted above, unfilled joints allow pavers to move under traffic and, thereby, impair structural integrity. For these reasons, the use of unfilled joints is neither recommended nor desirable practice for PICP.

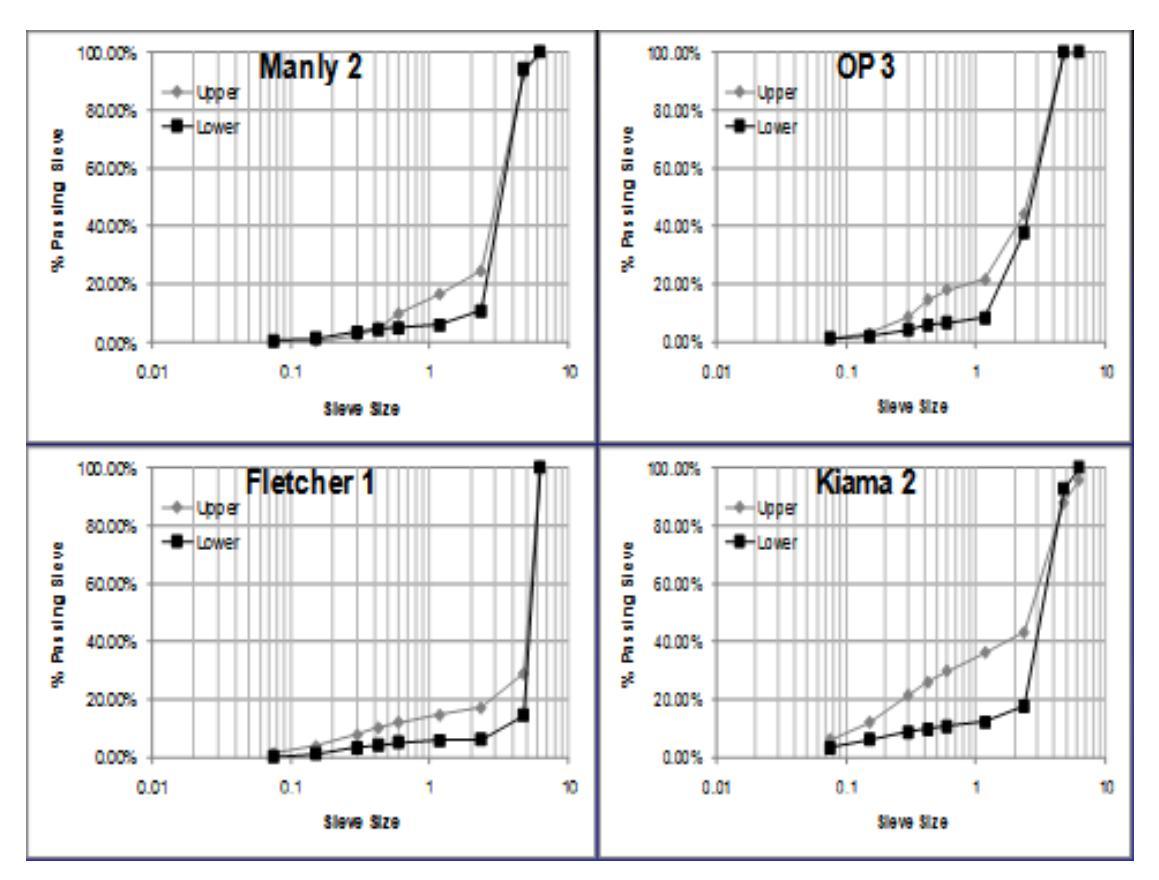
Figure 3. Typical jointing gradations comparing upper and lower joint material.

At 10 of the 14 locations it was found that there were more fine particles in the upper 30 mm than in the lower 30 to 60 mm of jointing material. Typical results are shown in Figure 3. These indicated that the increase in fines generally occurred in the particle size range of 0.2 to 2.0 mm.

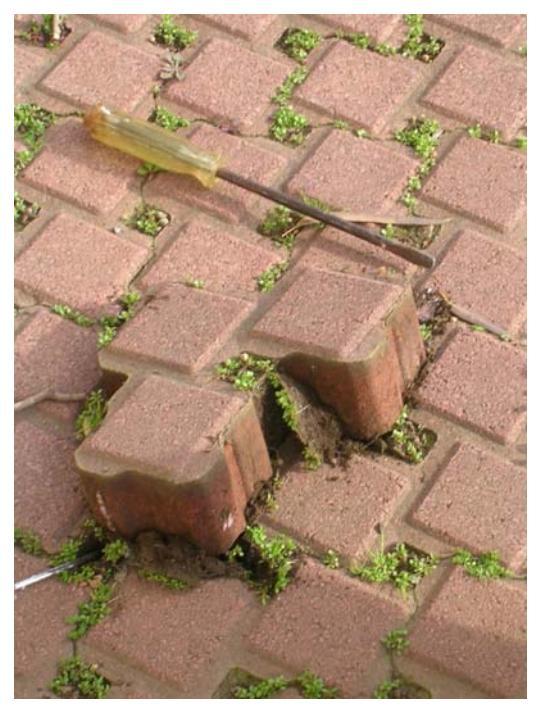
Although not widespread, weed growth along the joints or in the drainage openings was observed in a few lightly trafficked areas. The most heavily infested area is shown in Figure 4 and was located at Fletcher Lane, Woodville, SA. Excavation showed that the weed growth extended the full depth of the joints. Nevertheless, as shown in Table 2, the infiltration rate after 10 years was 80 mm/h

(500 l.sec/ha). This appeared to be because the high infiltration rates provided by the drainage openings compensated for any clogging.
