Portland Tries Permeable Interlocking Concrete Street Pavements

Known for its leadership in environment stewardship, The City of Portland, Oregon, placed over 19,000 sf (1,765 m²) of permeable interlocking concrete pavements in its Westmoreland neighborhood.

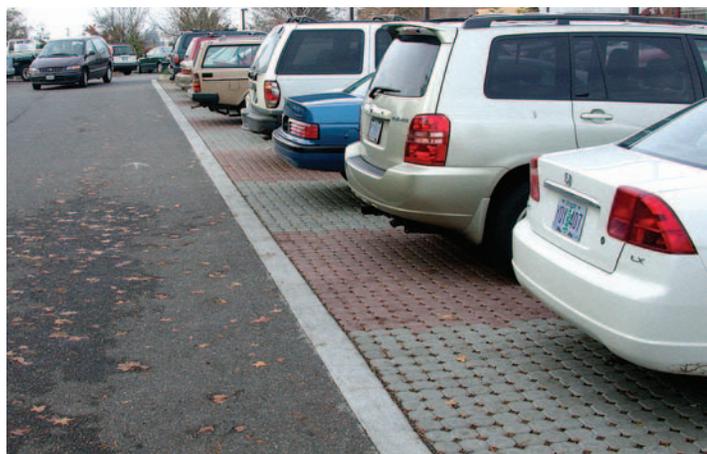
Figure 1. The City of Portland is not new to permeable pavements. The Multnomah Arts Center parking lot was one of the early projects.

a municipal arts center and at other locations. See Figure 1. The Westmoreland project, however, was the first time permeable interlocking concrete pavers (PICPs) were installed in a city public right-of-way.

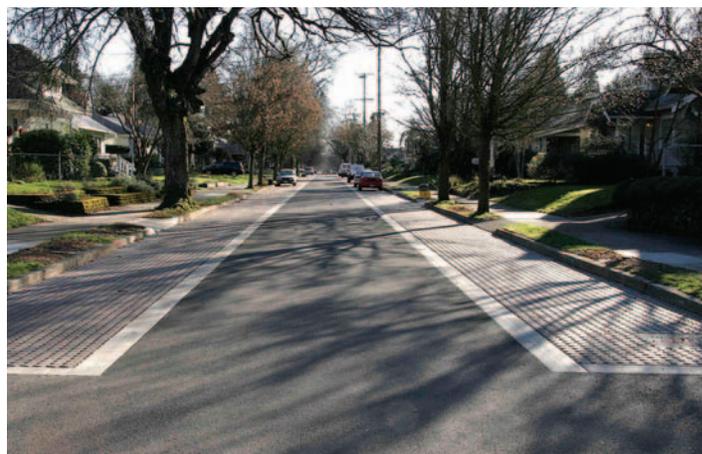
Figure 2. The permeable pavers receive runoff into an open-grade aggregate base, or "drainage blanket," that extends under the asphalt across the entire street. This boosts water storage and infiltration capacity.

According to Steve Townsen, P.E., Head of Engineering Services for Transportation and the Acting City Engineer, different pavement slopes and pavement configurations were employed to evaluate the long-term impact slopes would have on runoff and drainage. One city block has been paved the full width in permeable pavers with a centerline crown and cross slopes of 2% (see photo above). Two other streets have 6 ft 10 in. (2.1 m) parking strips paved with PICP on each curb side and a 12 ft (3.7 m) center lane paved in asphalt. See Figure 2.

base (called a “drainage blanket”) extends completely under the PICP pavement and streets with the asphalt center lane and PICP curb lanes. In other words, the drainage blanket offers additional storage and infiltration under the asphalt center lanes.

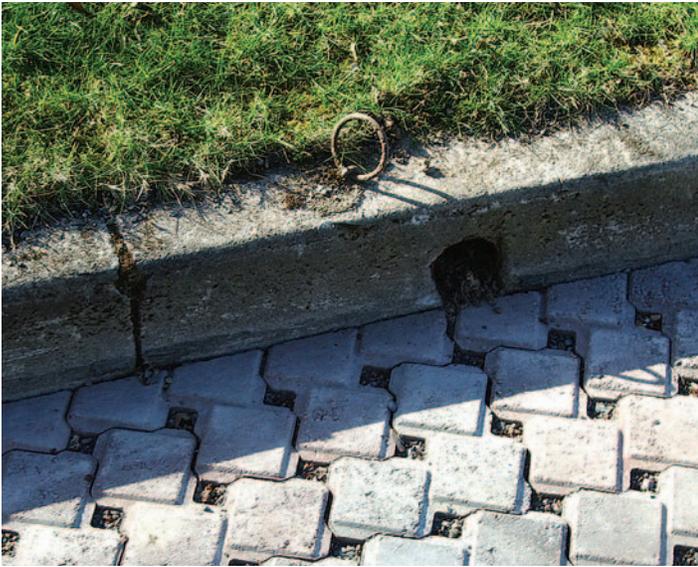
Figure 3. Portland has been reducing flows to combined sewer systems by disconnecting downspouts that daylight to street outlets like the one shown here. PICP offers another way to reduce combined sewer flows. The metal ring in the curb was a regional tradition that facilitates horse parking.

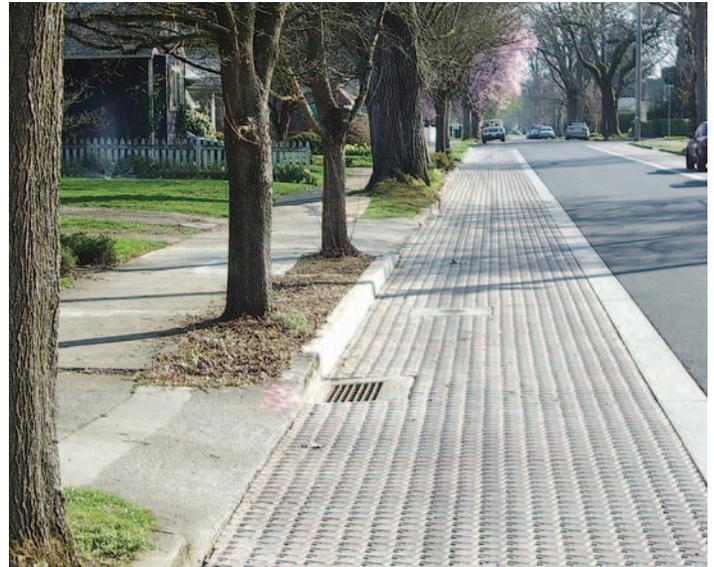
Figure 4. Deteriorated concrete curbs and driveway aprons were replaced. The existing storm drainage inlets and pipes were left in place for use as an overflow drain during heavy rainfall.

The City left the storm sewers in place since they didn’t require replacement. According to Mr. Townsen, “The storm sewer inlets can act as an overflow device if the permeable pavements were to become plugged or are completely full of runoff.” He noted that, “The neighbors were delighted with the results.” This was verified by the

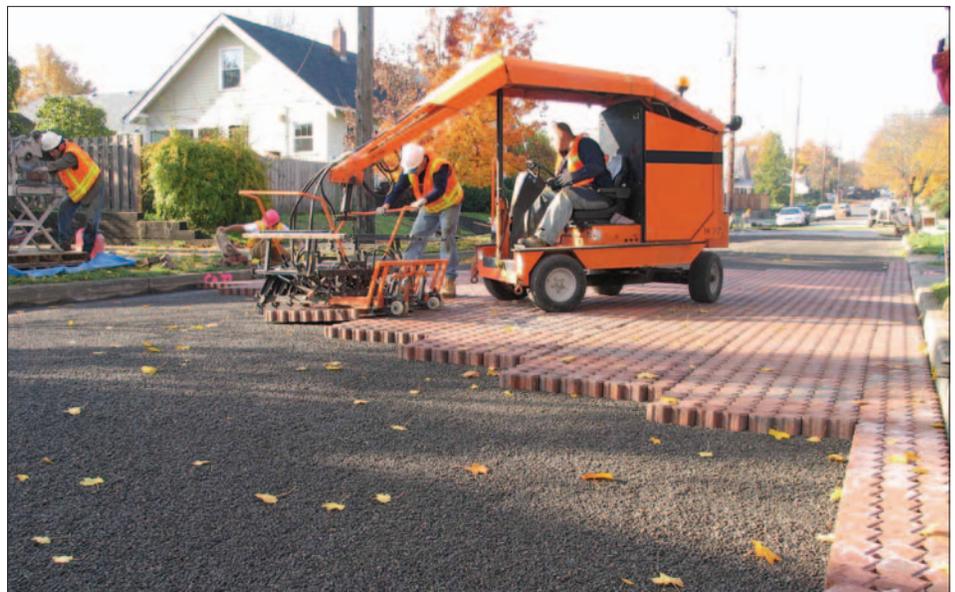
Figure 5. Mechanical installation equipment places the permeable pavers in the final laying pattern over the bedding course.

Figure 5 shows mechanical installation equipment set the paving units on a 3 in. (75 mm) thick bed of small size, open-graded stone (ODOT 02610.10) ranging in size from 9 mm to about 1/2 mm in size. The same material was used to fill the openings in the pavers. A layer of geotextile separated the bedding layer from the open-graded drainage blanket (ODOT 00360.11). The size of the base aggregate ranged from 100 mm to 2 mm. Figures 6 and 7 illustrate the stone bedding and drainage blanket base.

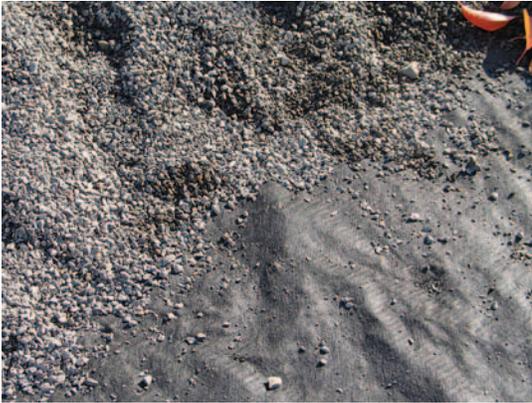
Figure 6. The bedding material was an Oregon DOT standard for small size, open graded stone.

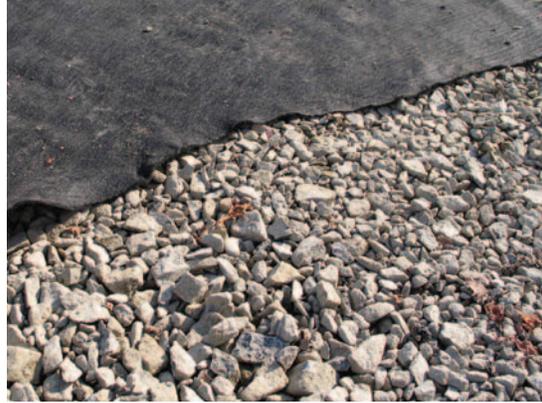
Figure 7. The drainage blanket of open-graded stone base ranged in size from 4 in. (100 mm) to 1/16 in. (2 mm), an Oregon DOT standard for large size, open-graded stone.

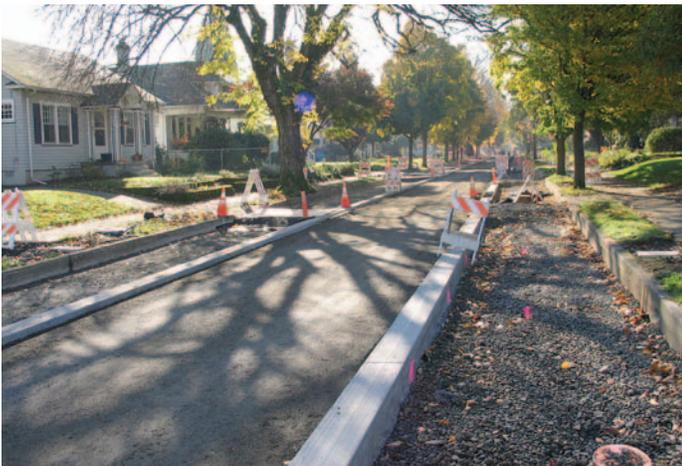
Figure 8. The drainage blanket base runs under the curbs across the width of the street. Geotextile was placed over the top of the drainage blanket in the asphalt center strip and dense-graded base compacted into place as shown here. Temporary driveways built with base and plywood allowed access to residents' driveways.

compacted and 4 in. (100 mm) thick asphalt placed in the center of the streets. Temporary driveways were built with base and plywood to enable access to residences along the streets. See Figure 8.

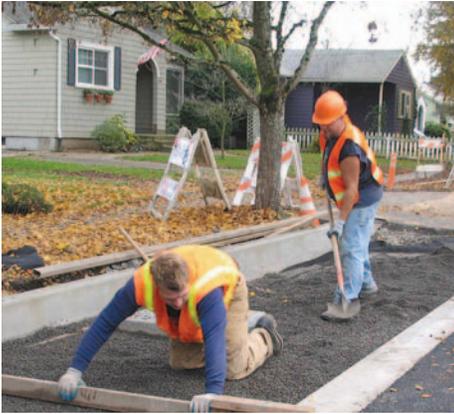
Figure 9. A makeshift screed levels the bedding course for the permeable pavers.

Geotextile was placed over the drainage layer in the PICP locations, then the 3 in. (75 mm) thick bedding layer placed and screeded to receive the pavers. Once installed, the pavers were compacted, openings filled, then compacted again. See Figures 9, 10 and 11. The PICP installer, manufacturer and project consulting engineer were ICPI members.

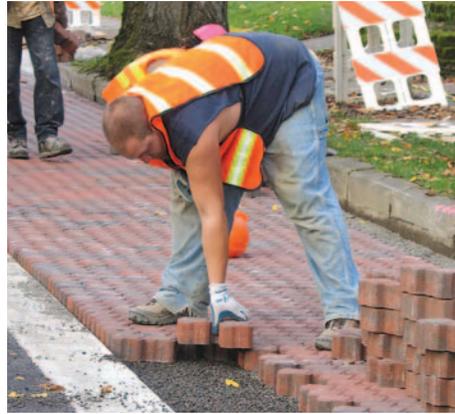
Figure 10. The width of new curb was set to accommodate mechanical placement of two paver layer widths within the 6 ft - 10 in. (2.1 m) wide parking strips. Some adjustments were necessary to fit the layers within the new curbs and the mostly uneven old curbs adjacent to the residences.

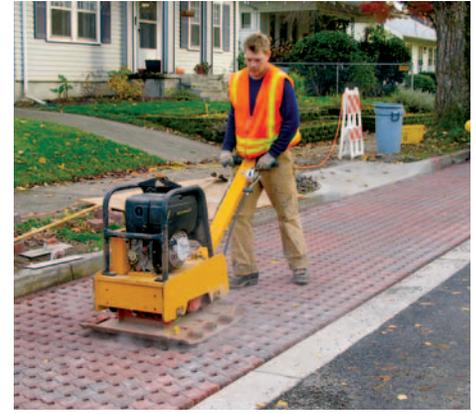
Figure 11. Installed pavers were compacted, the openings filled with the bedding stone and compacted to about 3/8 in. (10 mm) above the new concrete curbs.

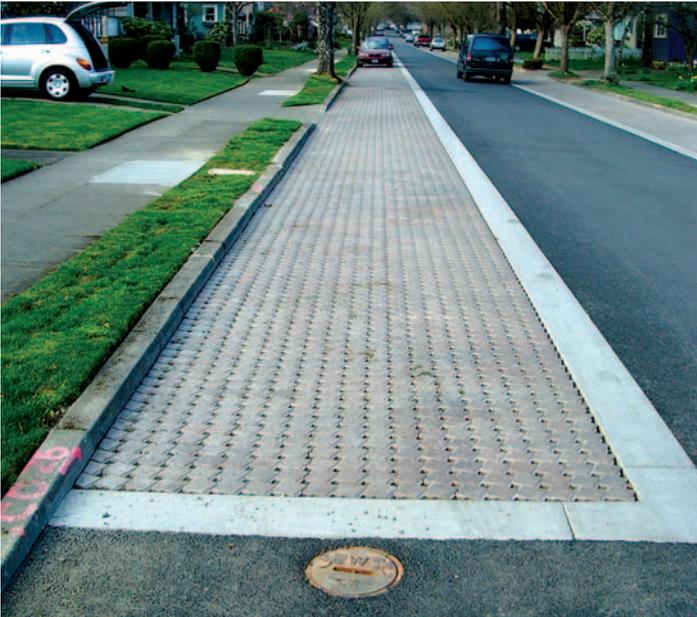
Figure 12. Capped, 4 ft (1.2 m) deep, 6 in. (150 mm) diameter perforated pipes serve as wells to monitor infiltration rates.

As part of the US EPA grant, the city will monitor the project using observation wells built into the lower elevations of the streets. These consist of vertical perforated pipes that enable measuring the rate of water infiltrating into the soil. See Figure 12.
