CASE STUDY

■ Application: Stormwater runoff reduction and quality

ANDREW H. WILSON CHARTER SCHOOL

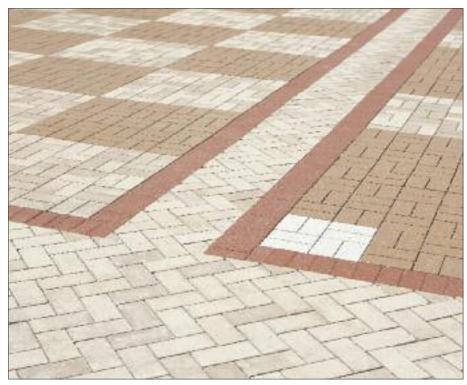
Permeable interlocking pavers are an attractive and functional drainage solution

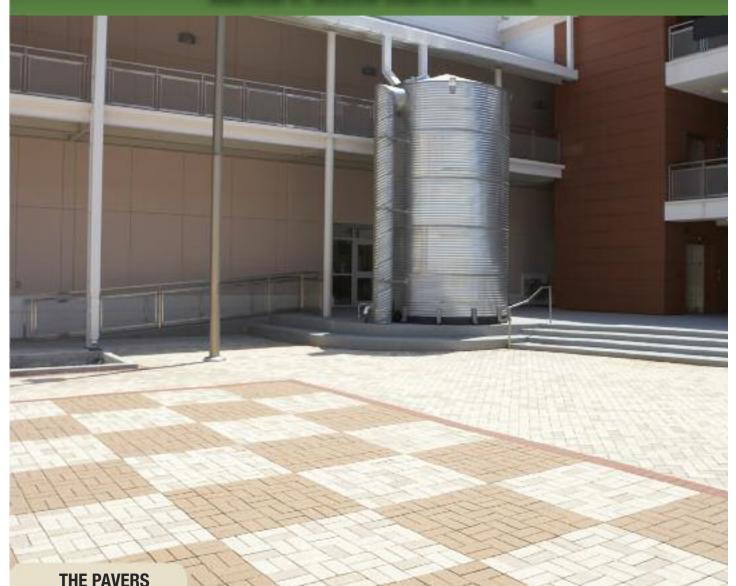
Eco-Priora™

The unique Eco-Priora[™] joint profile allows surface water to infiltrate into the pavement and its sub-layers. With initial permeability average flow rates of over 100 inches per hour, the Eco-Priora product, even with extended use, will still meet the majority of current stormwater management plans.
