# **Chicago's Mary Bartelme Park**

Landscape Architecture by site design group, Itd.

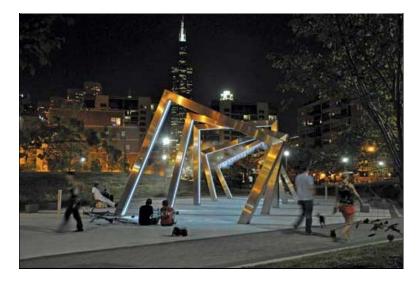
Water-activated photocatalytic pavers were installed below the steel arches to alleviate the urban heat island effect and reduce air pollution. On hot days, the arches produce a fine mist of vaporized water that immerses the area in a cloud. The water feature is designed to expend just 10 percent of the three gallons of water per minute that a typical Chicago spray feature uses. At night, built in LED lights illuminate the arches.

Beneath the gateway fountain, photocatalytic smog-eating pavers alleviate the urban heat island effect and reduce air pollution. Sunrays activate the photocatalytic reaction within the white TX Active pavers (Unilock), which destroy organic and inorganic compounds before they have a chance to adhere to their surface. Organic pollutants decompose into oxygen, water and harmless salts.

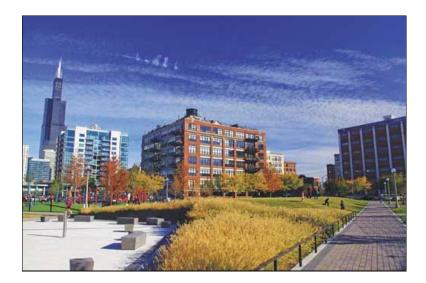
The primary paths on site are made of permeable pavers; runoff from across the site is directed into a leach field located under a central berm, where the stormwater is cleansed and infiltrated into the ground.

and the design team, who set a goal of zero infrastructure for the treatment of stormwater runoff at the beginning of the project. The primary intersecting paths on site are made of permeable pavers, where all runoff from across the site is directed. Water infiltrates below the surface and into a leech field located under a central berm, where the water is cleansed and infiltrated into the ground.

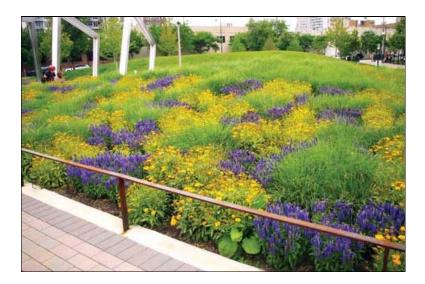
Weathering steel railings and retaining walls that reflect the West Loop's industrial past contrast with brightly colored seasonal plantings and ornamental grasses.

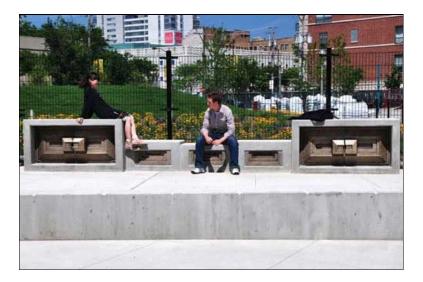
Terracotta artifacts salvaged from the infirmary building are nestled in seat walls, planter beds, and within the mounds. The unique details and industrial references within Mary Bartelme Park have made it a popular location for wedding and engagement photos.

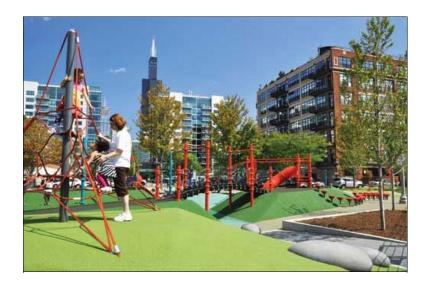
The playground provides inventive, exploratory play experiences and physical challenges for ages 2 to 12, and accommodates a number of physical and cognitive disabilities.

For families with small children, the northeast corner of the park is a popular stop, with a fully accessible playground comprised of custom play structures and complex topography. Formed from recycled rubber surfacing, the mounds are connected with a series of custom-designed bridges, slides, stepping pods, and climbing structures that promote creative, non-linear play. Without strictly separating age groups, the playground provides inventive, exploratory play experiences and physical challenges for ages ranging from two to 12, while accommodating a number of physical and cognitive disabilities. An enclosed seating area flanking the southwest corner provides a calm and contemplative community garden that contains a number of hidden design features. Terracotta artifacts salvaged from the demolished infirmary building are nestled in seat walls, planter beds, and within the mound, which are covered by profusions of more than 24,000 periwinkle-blue flowering bulbs in the spring. Surrounding the garden are weathering steel retaining walls that will oxidize over time, paying homage to the previously industrial use of the site and neighborhood. As they oxidize, the walls will develop a rich patina, changing to a rusted orange hue. Rustling river birch trees create a calmer entrance to the southeast, near custom egg-shaped benches.

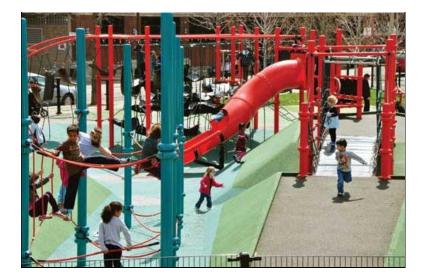
The fully accessible playground contains custom play structures (Berliner, Kompan, Landscape Structures) and complex topography that allows multiple age groups to play and be challenged together.

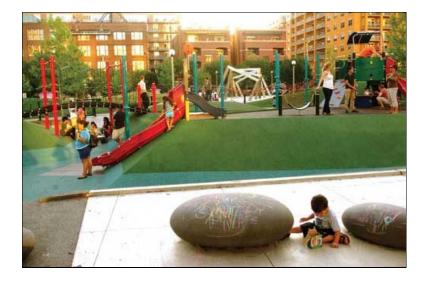
Mounds formed from recycled rubber surfacing (Total Surfaces) are connected

## with a series of custom-designed bridges, slides, stepping pods, and climbing structures that promote creative, non-linear play.

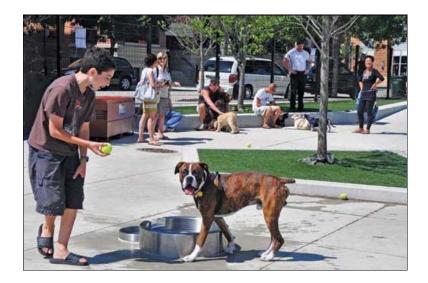
A sunken dog park includes an oversized, continuously filling water bowl. Antimicrobial and short-bladed artificial canine turf was installed for furry activities. Ramps, steps, and seat walls provide pet owners with places to rest and means for the dogs to exercise as well.
