## Repair of Utility Cuts Using Interlocking Concrete Pavers

# ICPI

INTERLOCKING CONCRETE  
PAVEMENT INSTITUTE

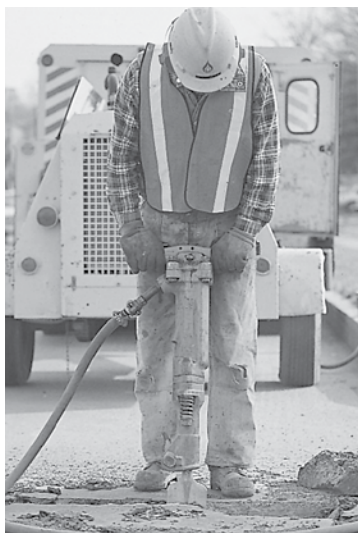
Figure 1. Repairs to utilities are a common sight in cities, incurring costs to cities and taxpayers.

North American cities have thousands of utility cuts made in their streets each year. Figure 1 shows a daily occurrence in most cities: repairs to underground utility lines for water, sewer, gas, electric, steam, phone, fiber-optic, or cable services. A sample is given below of the number of annual utility cuts in a few cities.

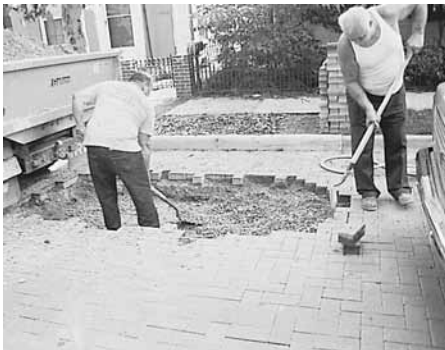
Figure 2. Removal of concrete pavers for a gas line repair in Dayton, Ohio.

Figures 2, 3, 4, 5 and 6 show the process of repair and illustrate the continuity of the paver surface after it is completed. The reinstated units are knitted into existing ones through the interlocking paving pattern and sand filled joints. Besides providing a pavement surface without cuts, the joints distribute loads by shear transfer. The joints allow minor settlement in the pavers caused by discontinuities in the base or soil without cracking.

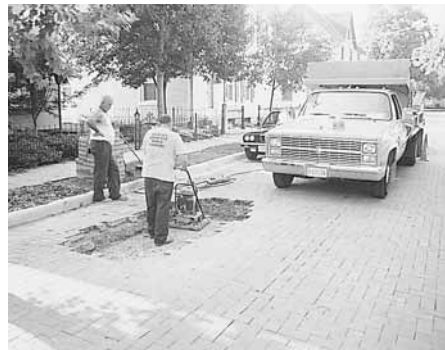
Figure 3. Compaction of the base

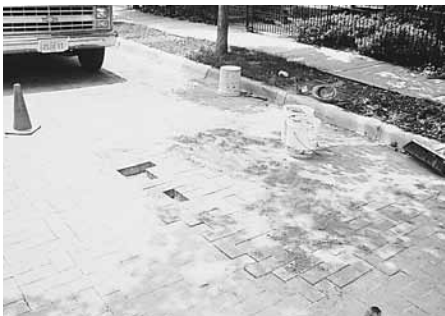
Figure 4. Reinstatement of the pavers, bedding and joint sand

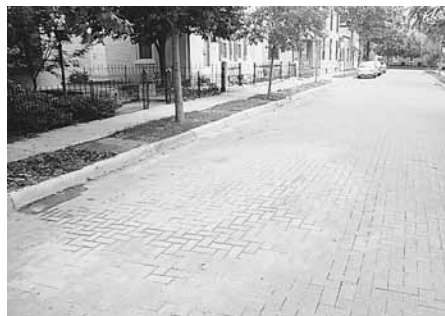
Figure 5. The final paver surface is continuous. There are no cuts or damage to the pavement.

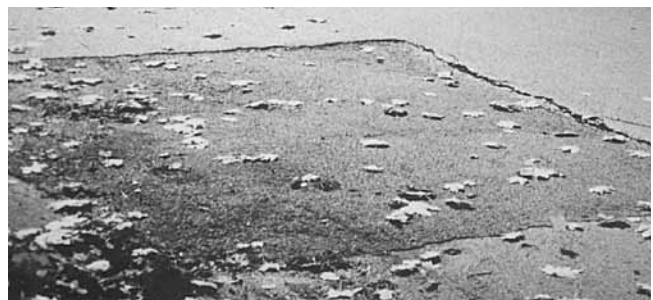
Figure 7. Pavement damage from settlement and shrinkage of cold patch asphalt.

Figure 7 shows the result of settlement and shrinkage of the cold patch asphalt in a London, Ontario, utility cut. The change in dimensions causes the edge of the cut asphalt to deteriorate, and settlement decreases riding quality.

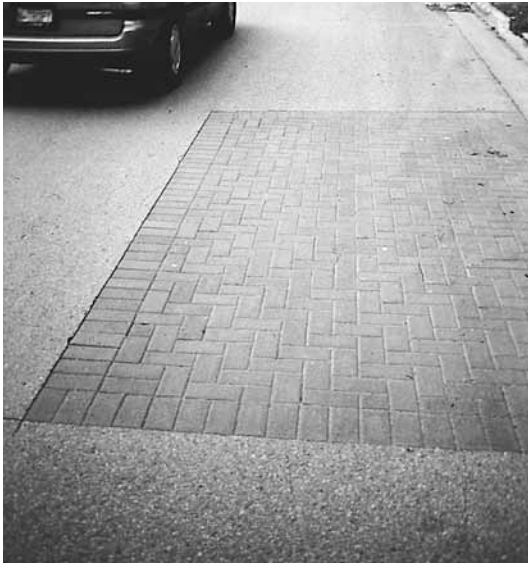
Figure 8. Utility cut repair in a residential area in London, Ontario.

Concrete pavers on low density concrete fill have been successfully used as a replacement for cold patch asphalt (Figures 8 and 9). They were first used as a temporary repair with the intent of being removed in the spring. However, the pavers performed so well that the City of London left them in place indefinitely. Several repairs were in streets subject to heavy truck traffic, as well as residential streets. Costs were less than using cold

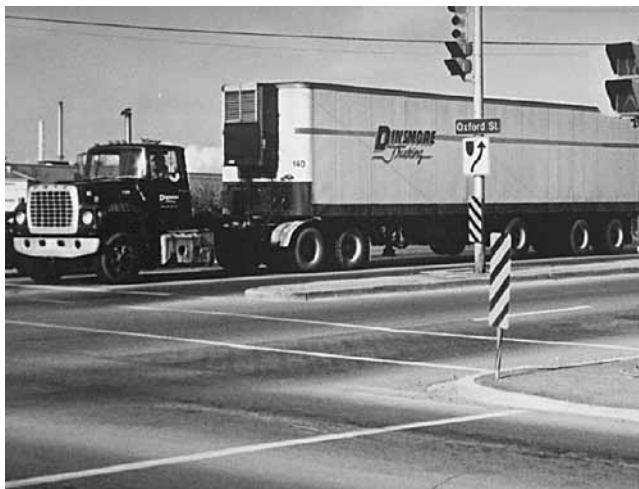
Figure 10. A patch of barely discernable pavers in a heavily trafficked intersection in London, Ontario

All repairs in London with concrete pavers and low-density concrete have produced a smooth surface transition from the asphalt to the pavers. The riding quality and safety has improved to the extent that the transition from one surface to the next can barely be discerned by the driver. The pavers were colored to match the appearance of the asphalt so there would be no substantial differences in appearance. Figure 10 shows such a patch of pavers blending with the surrounding pavement.

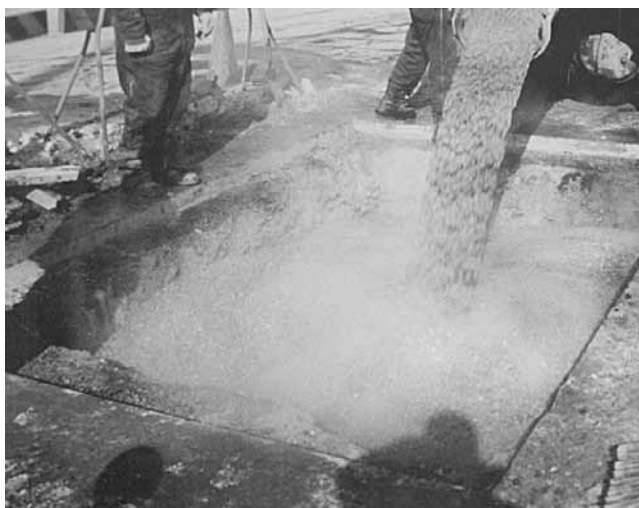
Figure 11. Low density concrete fill (unshrinkable fill) poured into a utility trench from a ready-mix concrete truck.

**Unshrinkable fill** poured into the trench is shown in Figure 11. The fills flows into undercuts, under the edge of the cut asphalt (providing additional support), and in places where the soil or base has fallen from the sides of the trench. These places are normally impossible to fill and compact with aggregate base or backfill material.

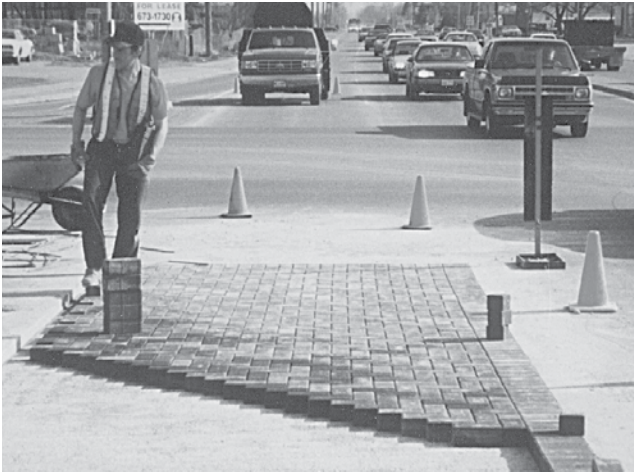
Figure 12. Pavers are laid in a 90 degree herringbone pattern between the border courses.

Place pavers between the border course in a 90 degree herringbone pattern (Figure 12). Joints between pavers should be between 1/16 and 5/16 in. (2 to 5 mm). Compact the pavers with a minimum 5,000 lbf (22 kN) plate compactor. Make at least four passes with the plate compactor. A small test area of pavers may need to be compacted to check the amount of settlement. The bedding sand thickness should be adjusted in thickness to yield pavers no higher than 1/8 in. (3 mm) above the edge of the asphalt.

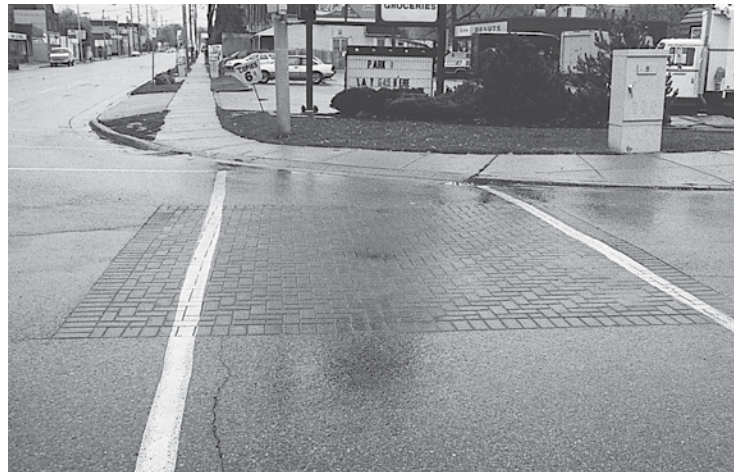
Figure 13. Concrete pavers in utility cuts can be painted as any other pavement.

other debris. The pavers may be painted with the same lane, traffic, or crosswalk markings as any other concrete pavements (Figure 13).
